# **Intel<sup>®</sup> Pentium<sup>®</sup> III Xeon<sup>™</sup> Processor Specification Update**

Release Date: December 2000

Order Number: 244460-023

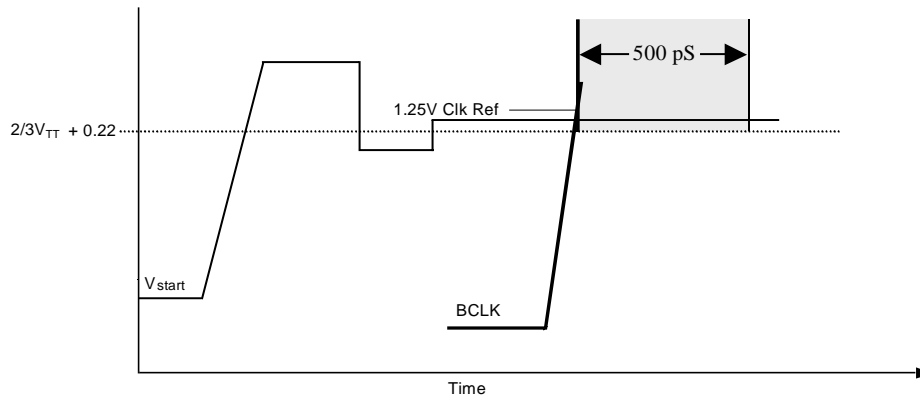
The published AGTL+ AC specification for  $V_{IH(MIN)}$  is  $(2/3 \cdot V_{TT}) + 0.1$  Volts.

Intel has characterized the new AGTL+ AC specification for  $V_{IH(MIN)}$  on the processor's RS0# signal to be:  $(2/3 \cdot V_{TT}) + 0.22$  Volts within 500 picoseconds following the rising edge of BCLK crossing the 1.25-Volt threshold. See below.

**Implication:** The deviation from the published specification results in decreased noise margin on the RS0# processor input. This decreased noise margin has been observed to be particularly detrimental in system environments where the RS0# processor input is being driven by an I/O buffer with a pull-up device (such as a p-channel transistor) that is switched off mid-cycle. Systems that employ I/O buffers that keep the pull-up device on for the entire cycle are significantly less affected by this erratum. The reduction in noise margin may lead to the generation of BINIT# (when enabled) resulting in a system reset, otherwise this condition may lead to a system "hang" condition.

**Workaround:** If a system design cannot meet the specification deviation, the following areas should be carefully examined to assure that additional margin exists in order to compensate for any deficit observed with respect to the newly characterized  $V_{IH(MIN)}$  specification:

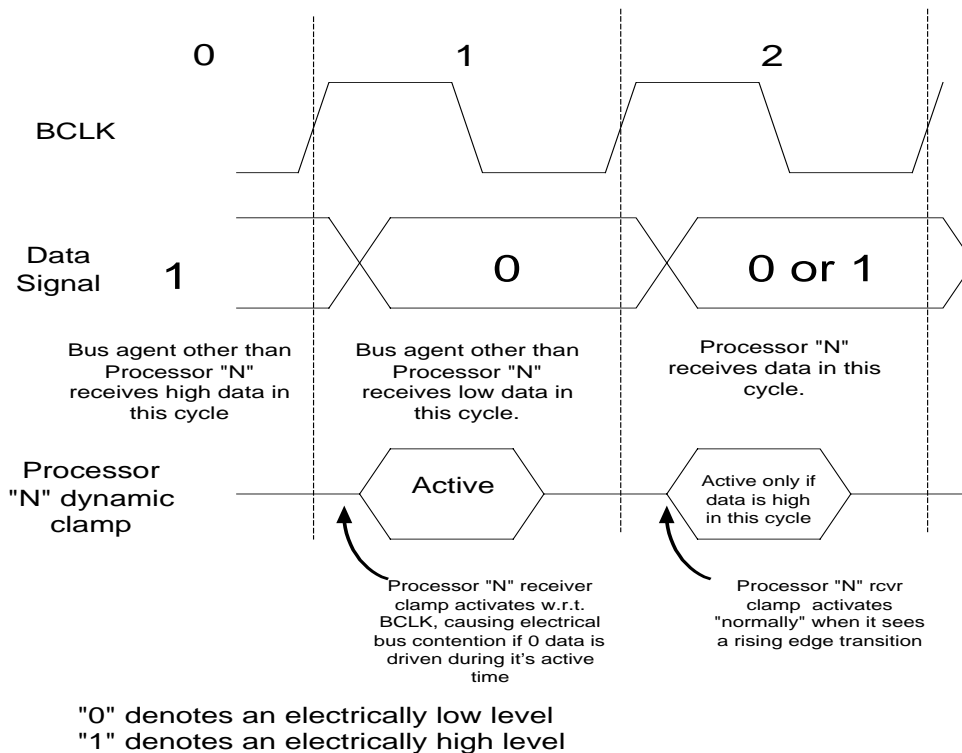
**Problem:** Falling edge ledge push-out and undershoot may be seen on AGTL+ data and data bus ECC signals. The AGTL+ receiver's dynamic clamp circuit activates (i.e. clamps the signal to an electrically high level) in certain cycles when data is driven to an electrically low level by another agent.

**Implication:** This erratum only occurs on a processor that does not receive data in that particular cycle. More specifically, this erratum only occurs when a specific processor does not receive data in the current BCLK period, but receives data in the very next period. Therefore, the processor inducing this falling edge noise (on data and data bus ECC signals) will not actually read the data in that cycle. See below for an illustration of this erratum affecting a processor denoted Processor "N". The falling edge ledges and undershoots may affect the signal quality and/or timing at agents that receive data in that cycle. Therefore, the impact of this erratum is highly dependent on system bus design.

**Workaround:** Evaluate system bus signal quality and timing margin at the valid receiving agent as a result of this falling edge noise. Due to dependence upon system bus design, bus layout may be evaluated to determine the need for improvements in signal quality and timing margin at the valid receiving agent as a result of this receiver-induced falling edge noise.
